# Inspection Report

Provided by:

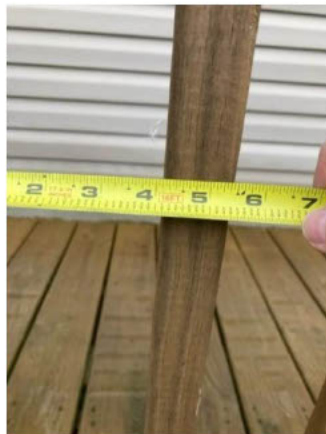
railing spacing should not allow a 4" sphere to pass.

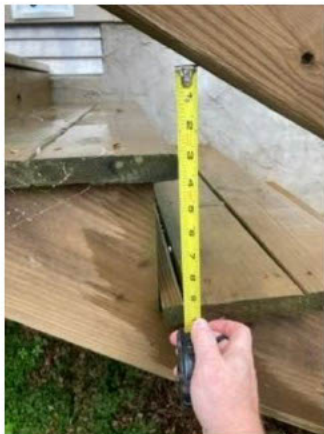
from step tread to bottom guard should not allow more than a 6" sphere to pass.

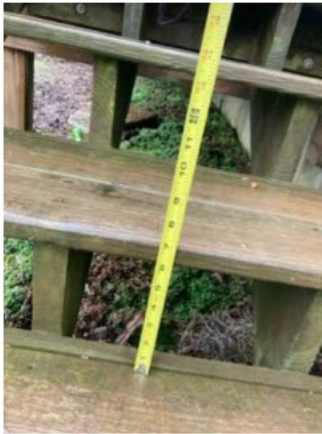
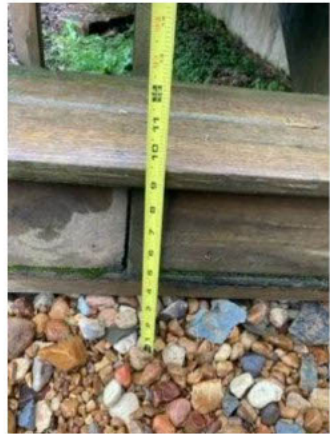
step risers should be between 4" and 7 3/4" in height and not differ more than 3/8". This step riser is approximately 9.5 inches while the other risers measure at approximately 7".

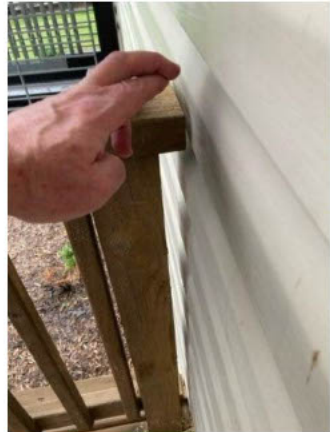
Guards must be able to withstand 200 pounds of pressure in any direction. This rail is not properly anchored and is movable by hand. The guard is at an appropriate height of 36".

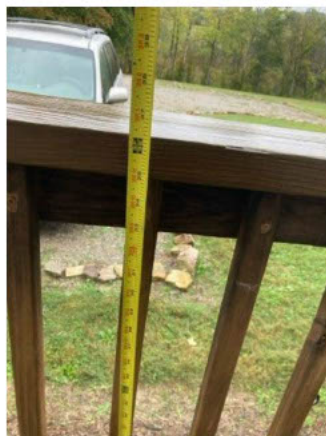
**Back Entrance Type** N/A**2.2) Back Entrance Conditions**

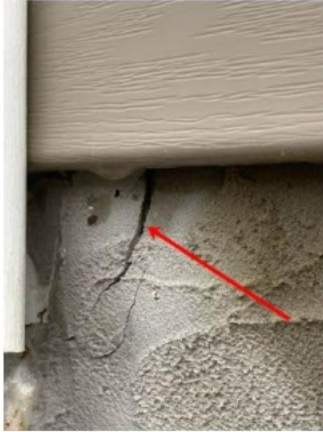
crack observed near the left front corner of the home. No evidence of flashing was observed between the siding and foundation.

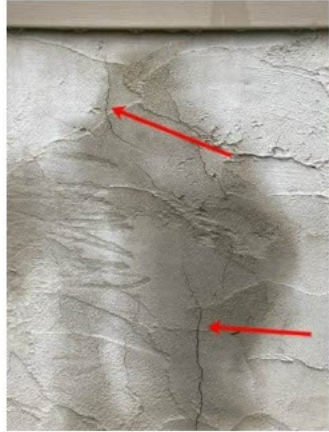
cracks observed in stucco treatment on the foundation where possible moisture intrusion is occurring

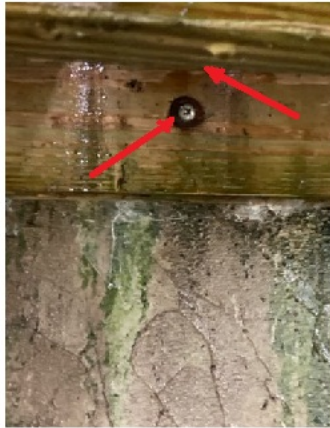
Flashing missing under deck ledger and rusty lag screw washer indicating regular moisture

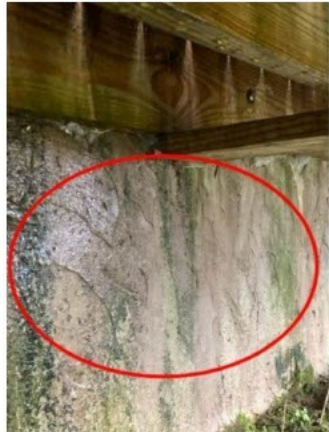
Algae growth under the front deck ramp indicating moisture accumulation

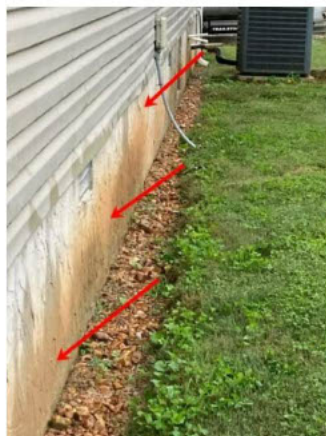
Water stains from poor drainage and persistent wicking action along the foundation. The foundation had poor drainage that results in water accumulation along the foundation.

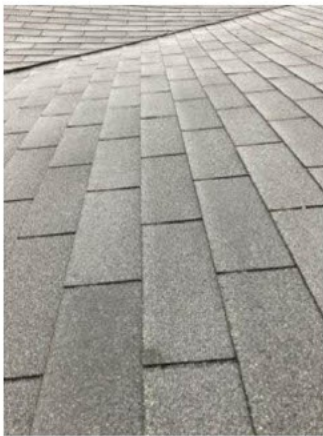
**Number of Layers** One.

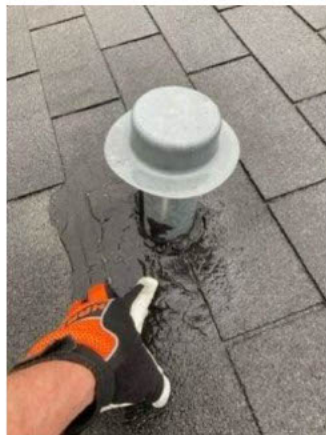
tar repair around vent penetration

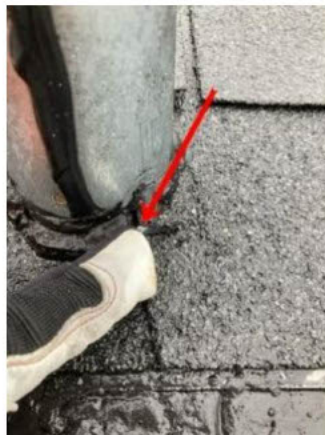
hole observed where previous patch job has failed around the base of a vent

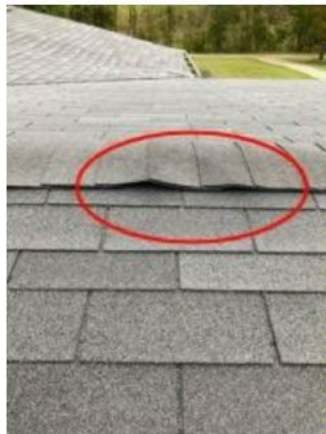
ridge cap shingles are lifting and allowing for possible water penetration

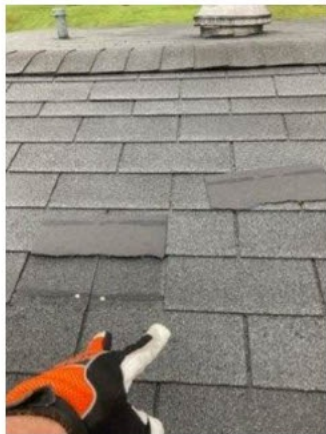
missing shingles and exposed nails

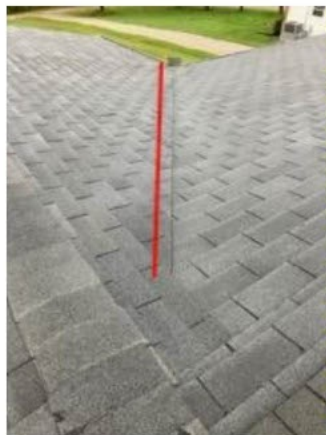
closed cut valley improperly installed with shingles cut along valley center. Should be offset 2" to the lesser drainage side as red line indicates.

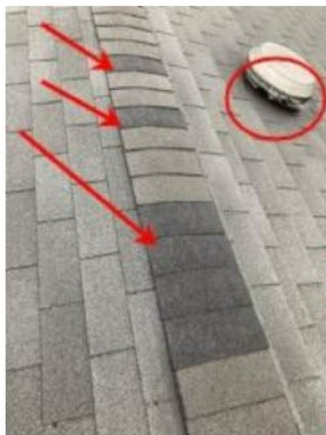
evidence of prior repairs to roof cap shingles. Also damage to roof vent can be seen in the background.

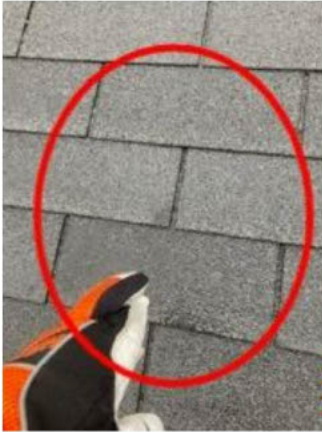
area along front right of home where roof is spongy

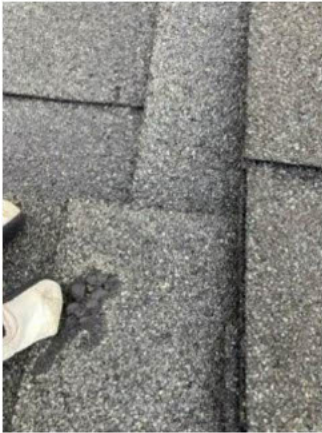
previously tarred and improperly installed nail that is again becoming exposed

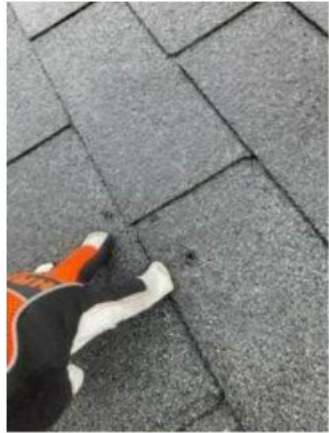
what appears to be nail penetrations that are unsealed

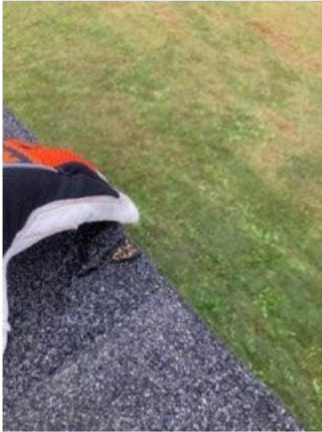
damaged shingle along the rake edge

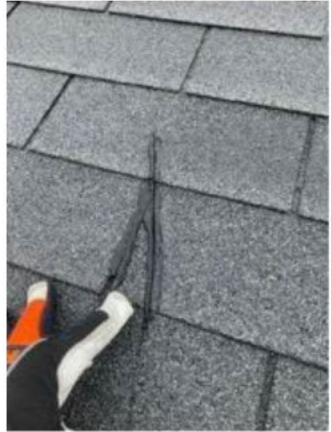
what appears to be sliced shingles that were poorly patched with tar

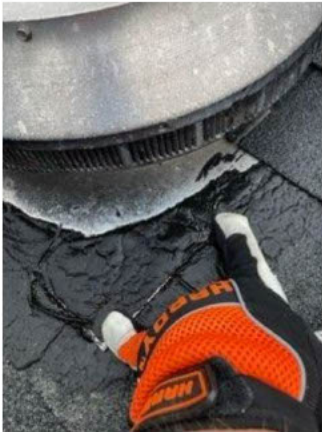
areas around the base of a roof vent where tar is deteriorating and allowing for possible water penetration.

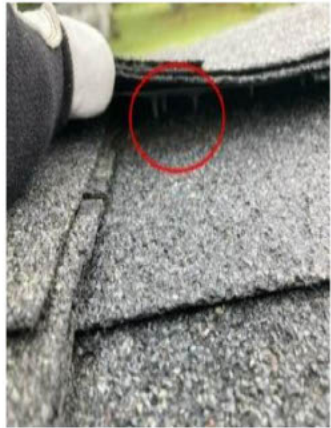
Nails showing where ridge cap shingles are lifting

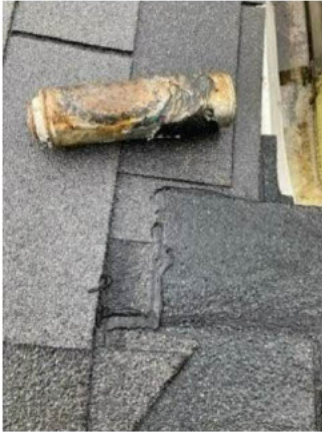
more tar at the base of the roof and an aerosol can found in the gutter

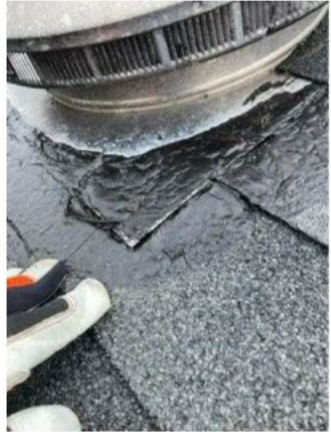
tar deterioration around the flashing of a roof vent

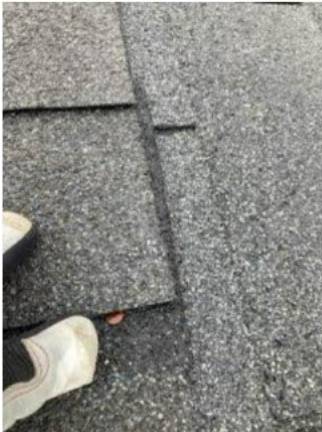
exposed nail head just showing below the overlapping shingle

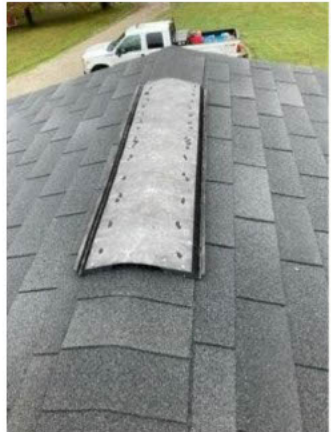
ridge vent installed over the porch attic space

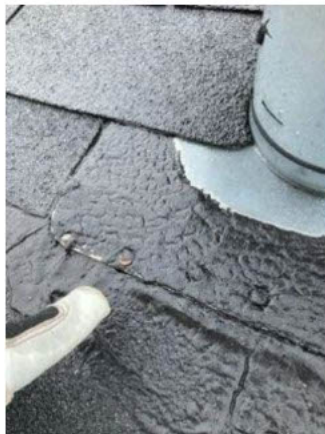
nails beginning to show as tar deteriorates at the base of the flashing for a vent.

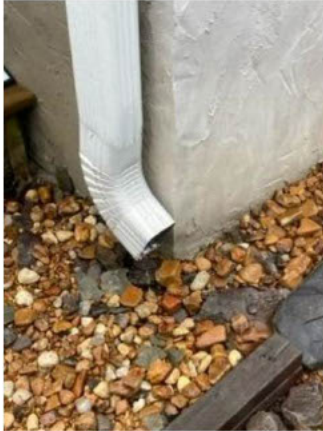
gutter needs to be extended to properly drain roof runoff away from the foundation.

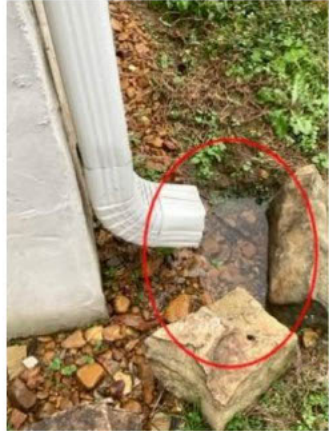
water pooling at the foundation from gutter discharge during a rain event.

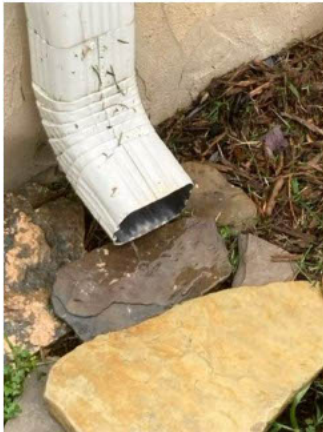
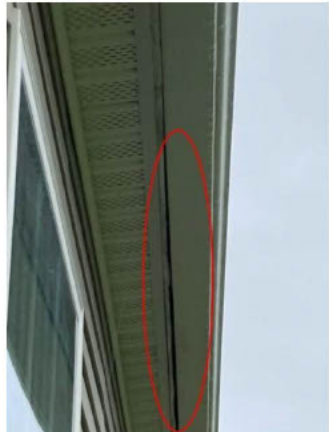
guttering was observed pulling away from the fascia board at the rear of the house. The homeowner indicated that it had also occurred and been repaired at the front of the home.

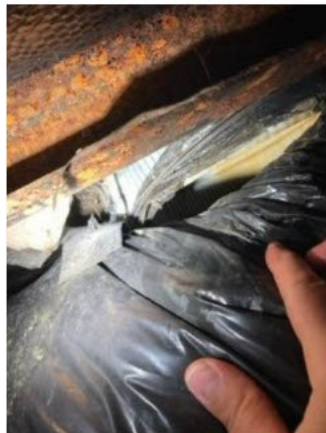
The return air duct has begun to come loose where the connection passes through the floor under the crawlspace.

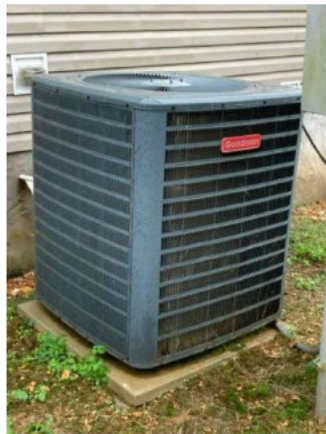
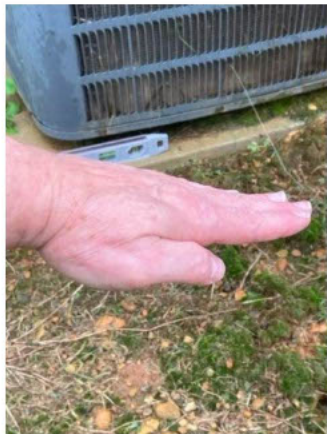
The base of the unit is not level. Also the condenser coils should be cleaned.

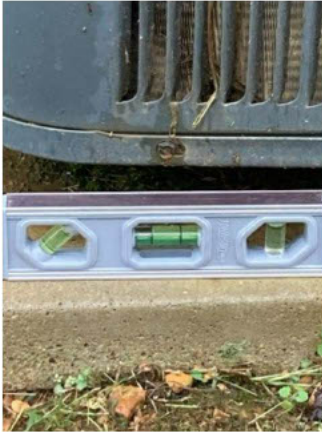
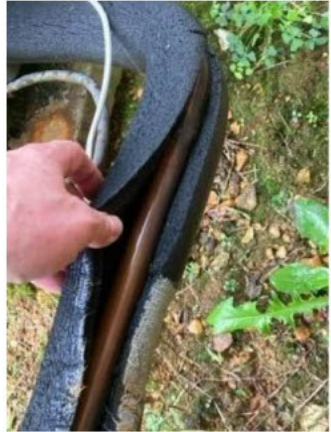
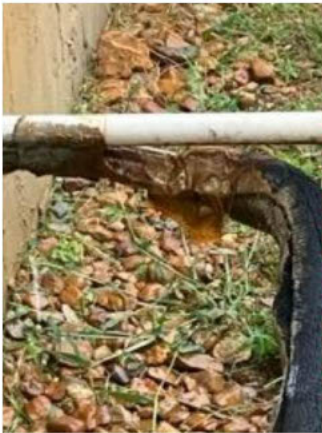
Insulation is damage and missing on the suction (return) line of the condenser unit. Recommend new insulation be installed

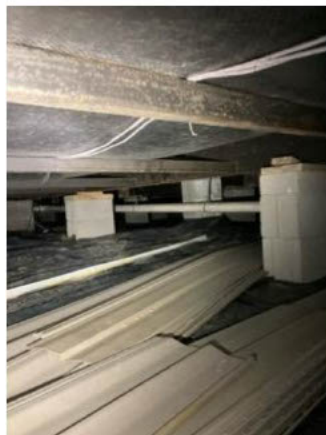
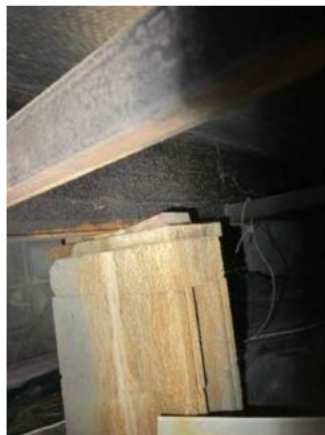
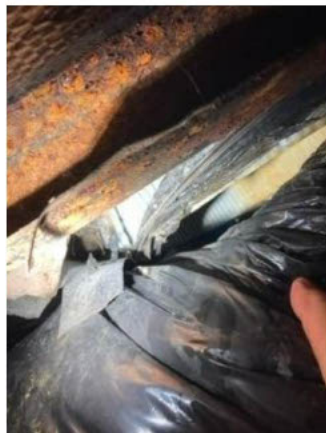
return duct needs to be reattached where it passes through the floor.

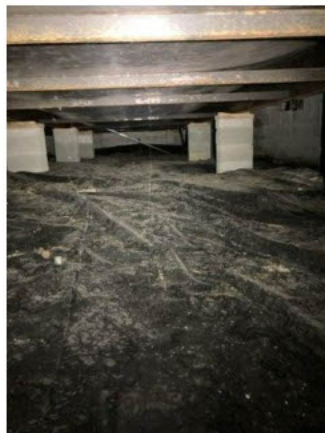
vapor barrier covering insulation and installed on the ground appeared to be in good shape at the time of inspection.

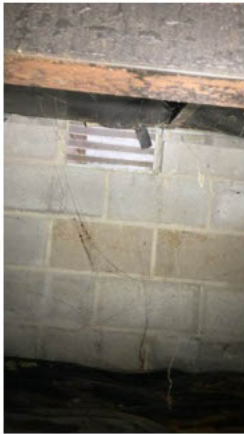
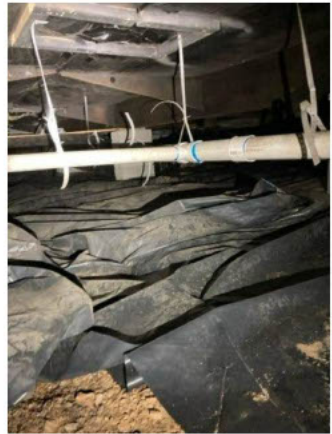
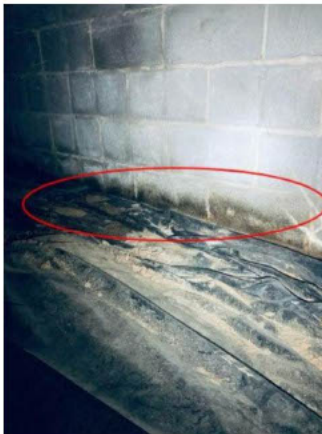
mold-like substance observed under the crawlspace at the foundation wall where water appears to be accumulating at the exterior front of the house (under the deck).

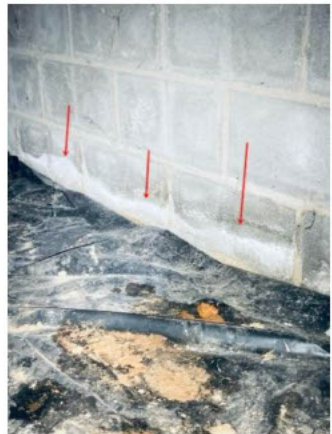
Efflorescence observed at the base of the foundation where water at the exterior of the home (under the ramp at the front of the house) appears to be accumulating from a combination of loose guttering, poor drainage around the foundation, and lack of flashing between the siding and the ledger board.

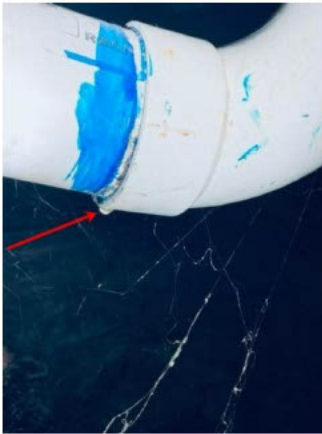
slow drip observed on a drain pipe under the crawlspace at the right rear of the home.

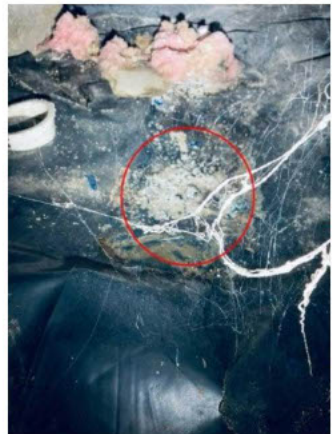
small area where waste water has accumulated from a slow leak in the pipe.
